THESIS

EFFECTS OF POST-FIRE MULCH APPLICATIONS ON HILLSLOPE-SCALE EROSION

Colorado State University

Fall 2023

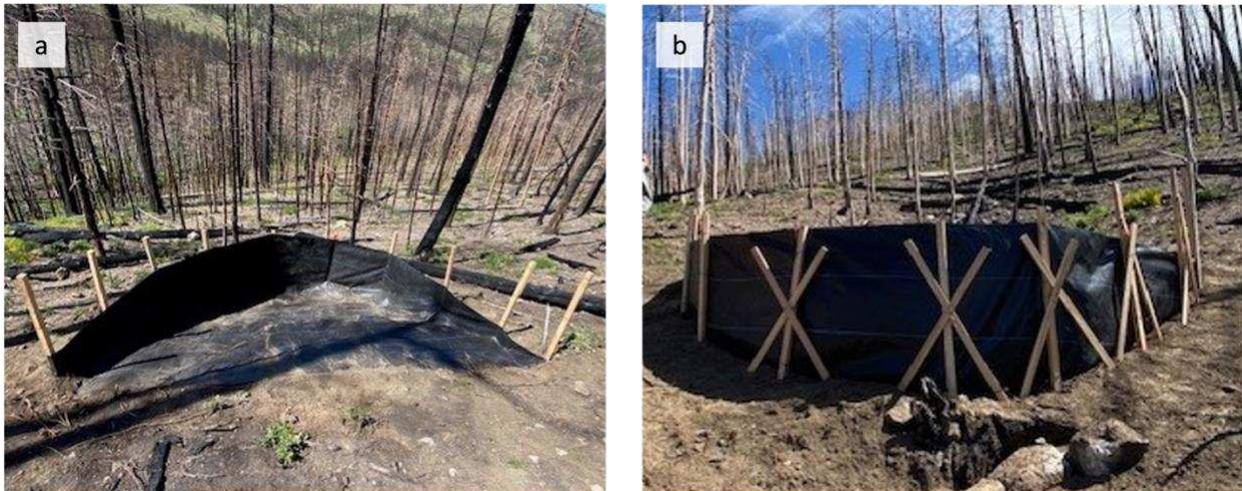
Figure 3. View of sediment fences (a) from above, looking downslope (b) from below, looking upslope.

Eight sediment fences were installed amongst the swales; six fences positioned to follow flow paths of swales on the convergent hillslope, and two fences in the planar plots for comparison between planar and convergent hillslope erosion (Figure 2). Contributing areas were then delineated based on fence location using Digital Elevation Models (DEMs) derived from drone imagery and Structure from Motion (SfM) methods, which had a spatial resolution of 6.4 cm. The size and dimensions of sediment fences were determined based on the width of each swale. The fences were constructed in a U-shape design to capture sediment eroded from the hillslope, and subsequently transported by runoff (Figure

3a). The U-shaped dimensions of the fence were established by vertically posting wooden stakes on the exterior of the landscaping fabric. Bailing wire was used to reinforce the wooden stakes. Although other studies used rebar to support the wooden stakes (Schmeer, 2014; Benavides-Solorio & MacDonald, 2005), underlying soil within swales at the MW study site was too rocky. Instead, two additional wooden stakes were placed in an “X” shape to strengthen fence posts (Figure 3b). To secure the landscaping within the fence, several eight-gauge landscape staples were driven into the fabric. Eight-gauge landscape staples were also placed along the fabric’s edge, the chord of the semi-circle fence shape, at the soil surface. This placement aimed to minimize potential sediment transport from going underneath the fabric during high-intensity storm events.

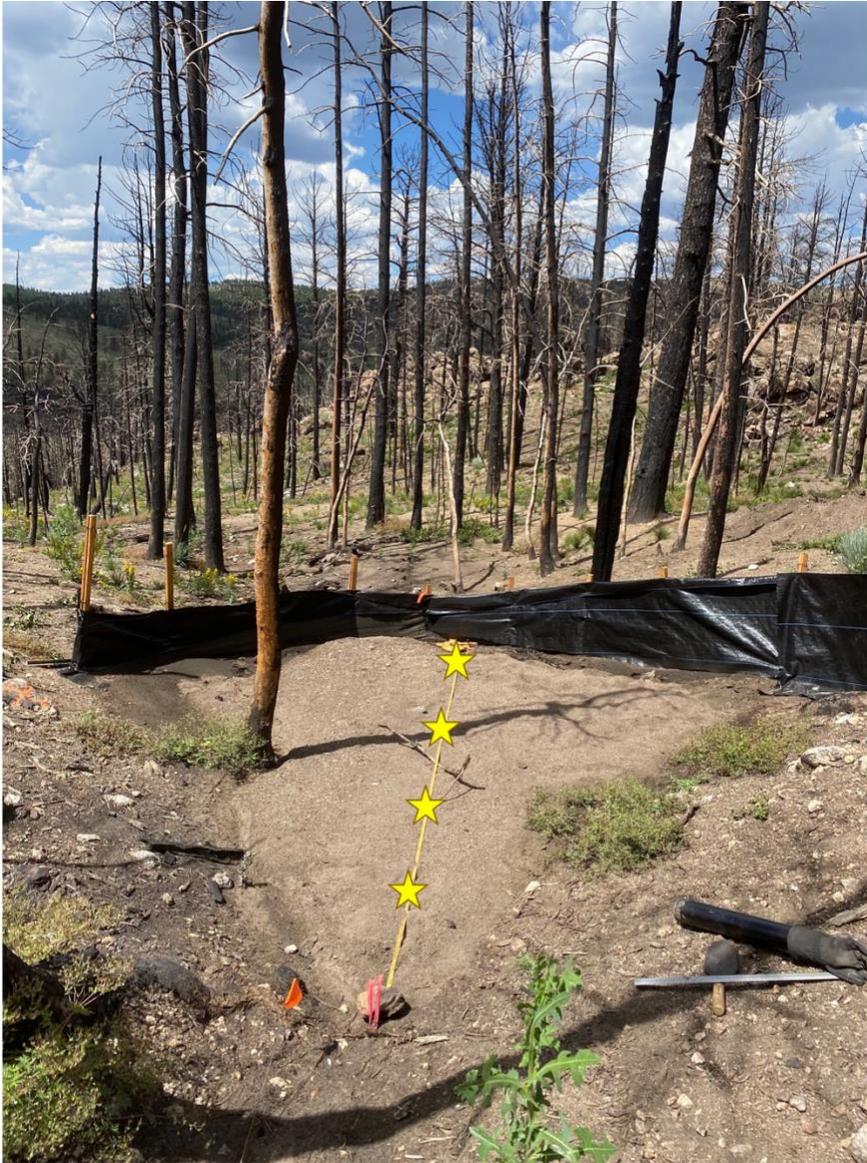
Figure 4. Location of samples collected at each fence at 1 m, 2 m, 3 m, and 4 m, where sediment was present.

For each sediment generating storm event, sediment samples weighing a minimum of 0.1 kg were collected from each fence and placed in Ziploc bags. The samples were taken every meter along the central axis of the fence, starting from downslope (1 m inside the fence) and progressing upslope towards the edge of the fabric, or until the end of sediment deposition from the specific storm event (Figure 4). Due to the rocky nature of the sediment, samples were collected without known volumes. Instead, total depth of each sample was recorded. Samples were later brought to the lab to determine water content.

the fence (Figure 4). This calculation was performed for each storm event, allowing for comparisons of average water content across different storms. The sample water content was used to adjust the wet sediment mass to a dry mass for sediment load (Mg). The sample's dry mass was normalized by swale contributing area to get sediment yield (Mg/ha).

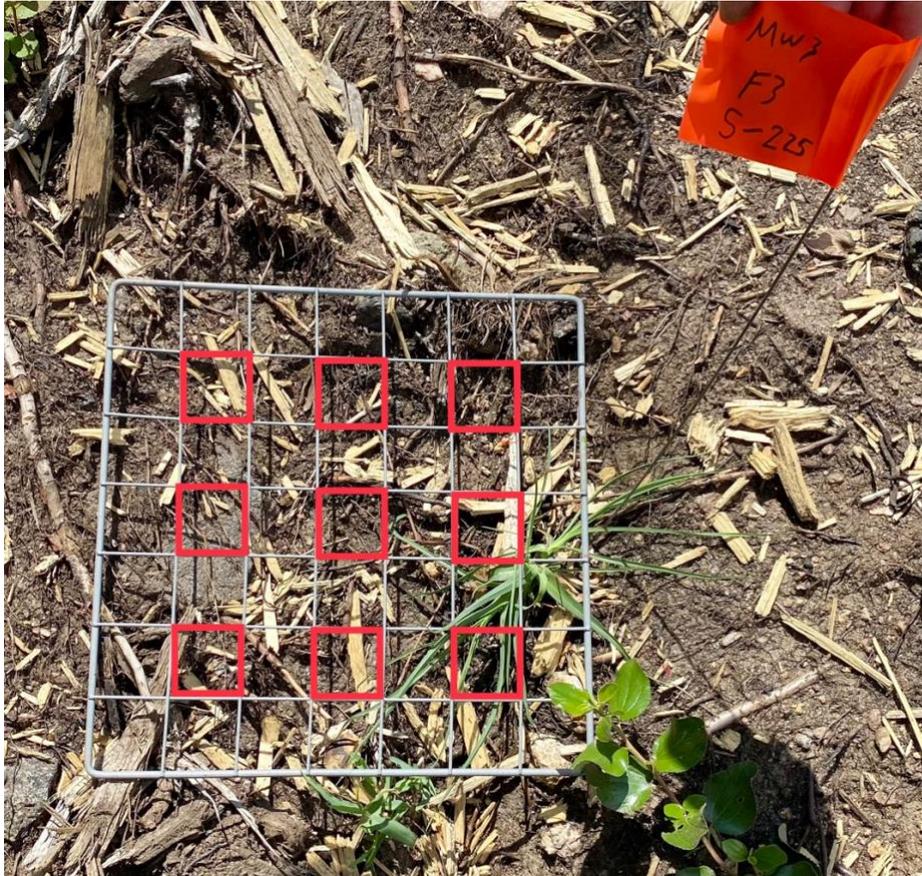
Figure 5. Grid used for ground cover surveys. The red squares, 4.4 cm by 4.4 cm outline the squares where measurements were taken (1 measurement/square).

To evaluate the effect of wood mulching treatments, surface cover surveys were conducted from 7/1/2022 to 10/12/2022. A total of 20 surveys were completed across all eight swales to capture changes in cover over time, both before and after the application of mulching treatments. Measurements were collected pre- and post-mulching and split into four groups: pre-mulch (7/1 to 7/13), post-mulch 1 (7/27), post-mulch 2 (8/10), and post-mulch 3 (9/21 and 10/12). Transects were established along the central axis of each swale, and across the entire length of the swale up to the hillslope ridge. The swales varied in length, ranging from 100 m to 350 m with an average length of approximately 253 m (Table 1). Measurements were collected at 5 m intervals, starting at the base of the swale above the sediment fence. This sampling approach ensured that there were enough data points, at least 100 points per transect, to capture a comprehensive representation of the swale's surface cover. A tape measure was used to mark survey points within each transect. Pin flags were placed to mark locations of the points in the transect and ensure that cover could accurately be re-measured at the same points in subsequent surveys. A precise location with latitude/longitude with < 0.5 m accuracy was recorded for each point along the transect using a Juniper Systems Geode GNSS Receiver (Juniper Systems, Logan, Utah). A 36.5 cm by 30.5 cm survey grid, split up by 4.4 cm by 4.4 cm squares, was used at each point to measure cover. For each point in the transect, measurements were taken from nine predetermined squares of the grid and randomly selected within each square (Figure 5). The nine measurements were tallied by surface cover type. Cover classes were categorized as bedrock, rock > 10 cm diameter, rock 1-10 cm, rock < 1 cm diameter, bare soil, tree standing, tree fallen, live vegetation,

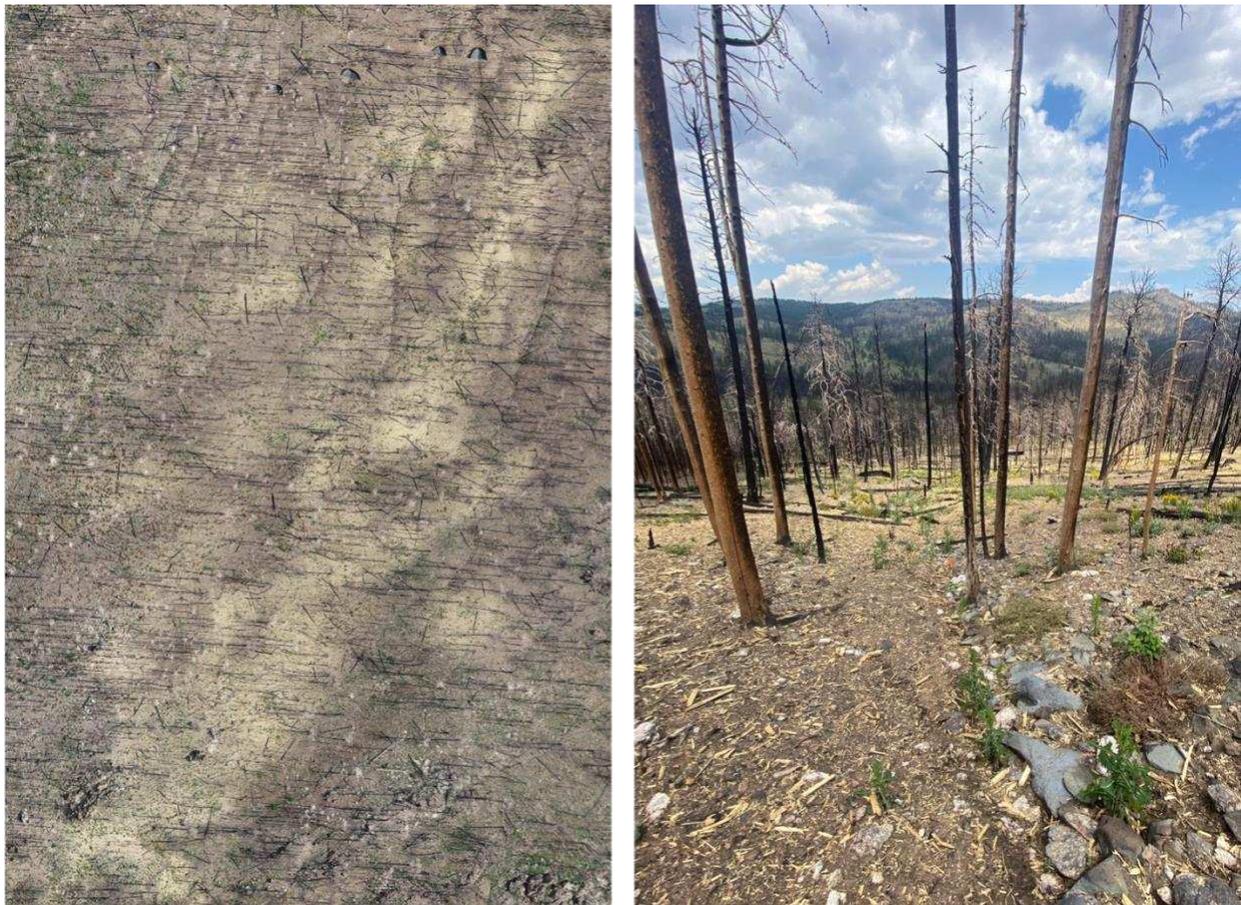
Figure 14. Initial mulch cover distribution drone imagery (left) and on-the-ground (right).

Several other factors may have limited the effectiveness of mulch applications in this study. First, the hillslopes are very narrow, and this made it difficult for the helicopter operators to place the mulch exactly within hillslope boundaries. The mulch was dropped in clumps and was not evenly spread across the full hillslope areas (Figure 14). Initial wood mulch distribution that promotes even coverage is favorable, however, helimulching can result in uneven distribution and clumping (Robichaud et al., 2013b; Robichaud et al., 2010).
