THESIS

GEOMORPHIC ANALYSIS OF THE MIDDLE RIO GRANDE –
ELEPHANT BUTTE REACH, NEW MEXICO

Colorado State University

Spring 2012

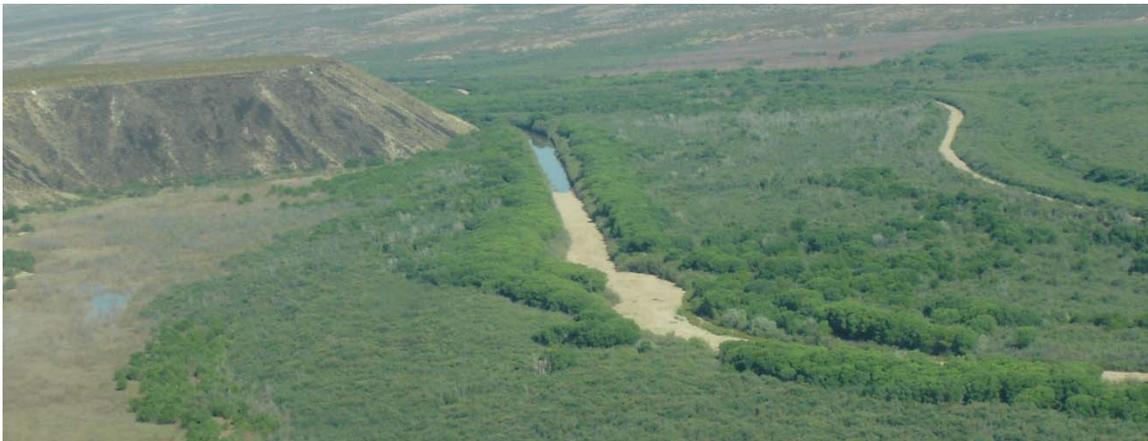
Figure 1.4 Aerial View of Tiffany Plug in 2005

Historically, sediment plugs have formed along the Middle Rio Grande, completely blocking the main channel of the river. In 1991, 1995, and 2005, the Tiffany Plug formed in the upstream end of the Elephant Butte Reach at Agg/Deg 1683 (River Mile 70.23), as seen in Figure 1.4. In 2008, the Bosque del Apache Plug formed between Agg/Deg 1531 and 1550 (River Mile 82.5 – 80.81), about 7 miles upstream of the Elephant Butte Reach. Little is known about the formation of sediment plugs; why they form, where they form, and how best to manage river flows to prevent the formation of sediment plugs. The consequences of sediment plugs in the Middle Rio Grande are significant. The presence of sediment plugs blocks the main channel of the Rio Grande
