THESIS

TESTING OF A FULL-SCALE  
MASS TIMBER DIAPHRAGM

Colorado State University

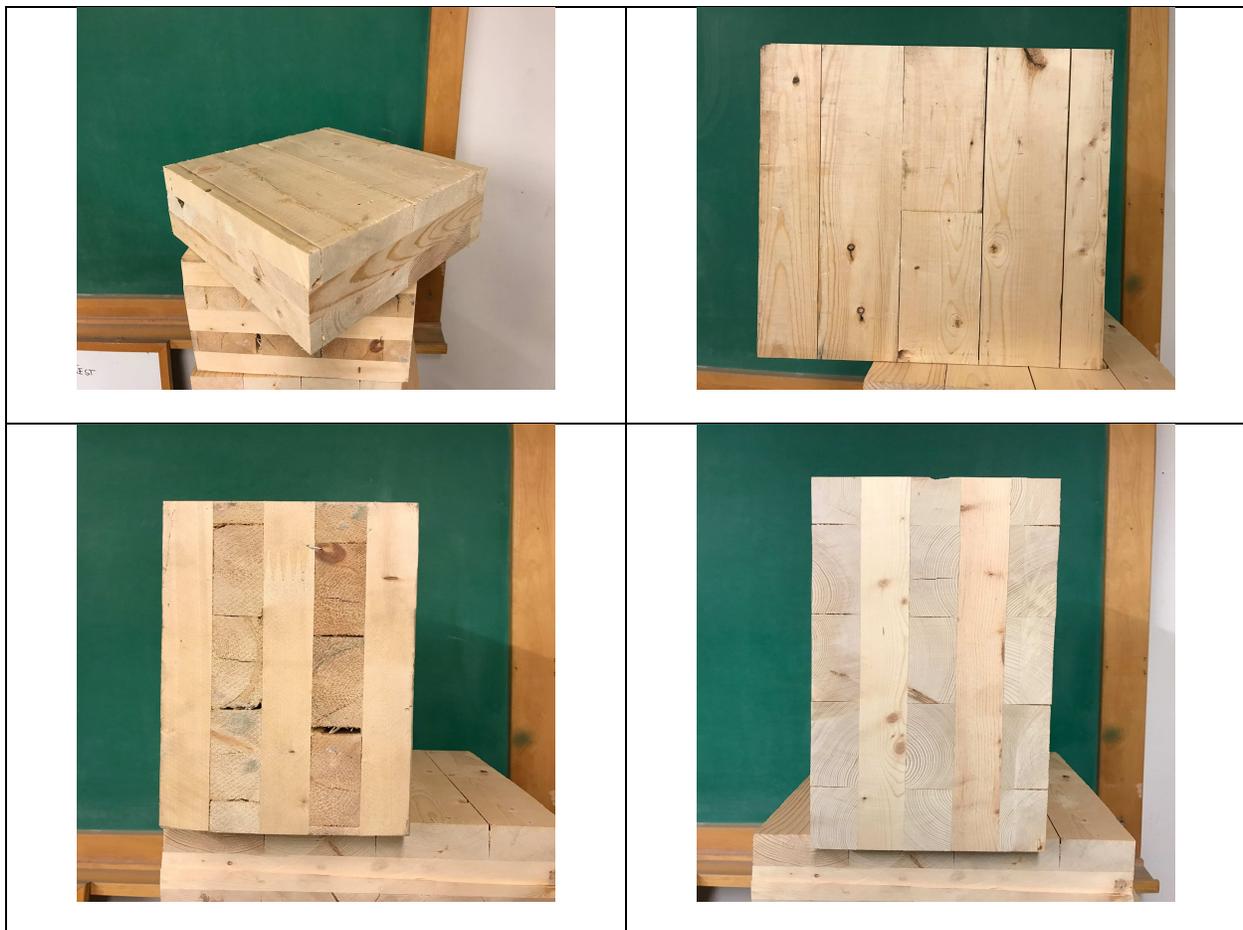
Figure 1.3 CLT Panels

CLT is made from a variety of dimension lumber species and grades. Some common examples include Spruce-Pine-Fir as indicated earlier in Table 1. These lumber boards are stacked perpendicular to each other and attached together. Glue is typically used to attach the dimension lumber. Sometimes fasteners are also used although this is less common (CLT Handbook, 2013). This results in a wood panel that has dimension lumber boards going in both the parallel and perpendicular directions (CLT Handbook, 2013). Figure 1.3 illustrates a few different sizes and views of small CLT panels.

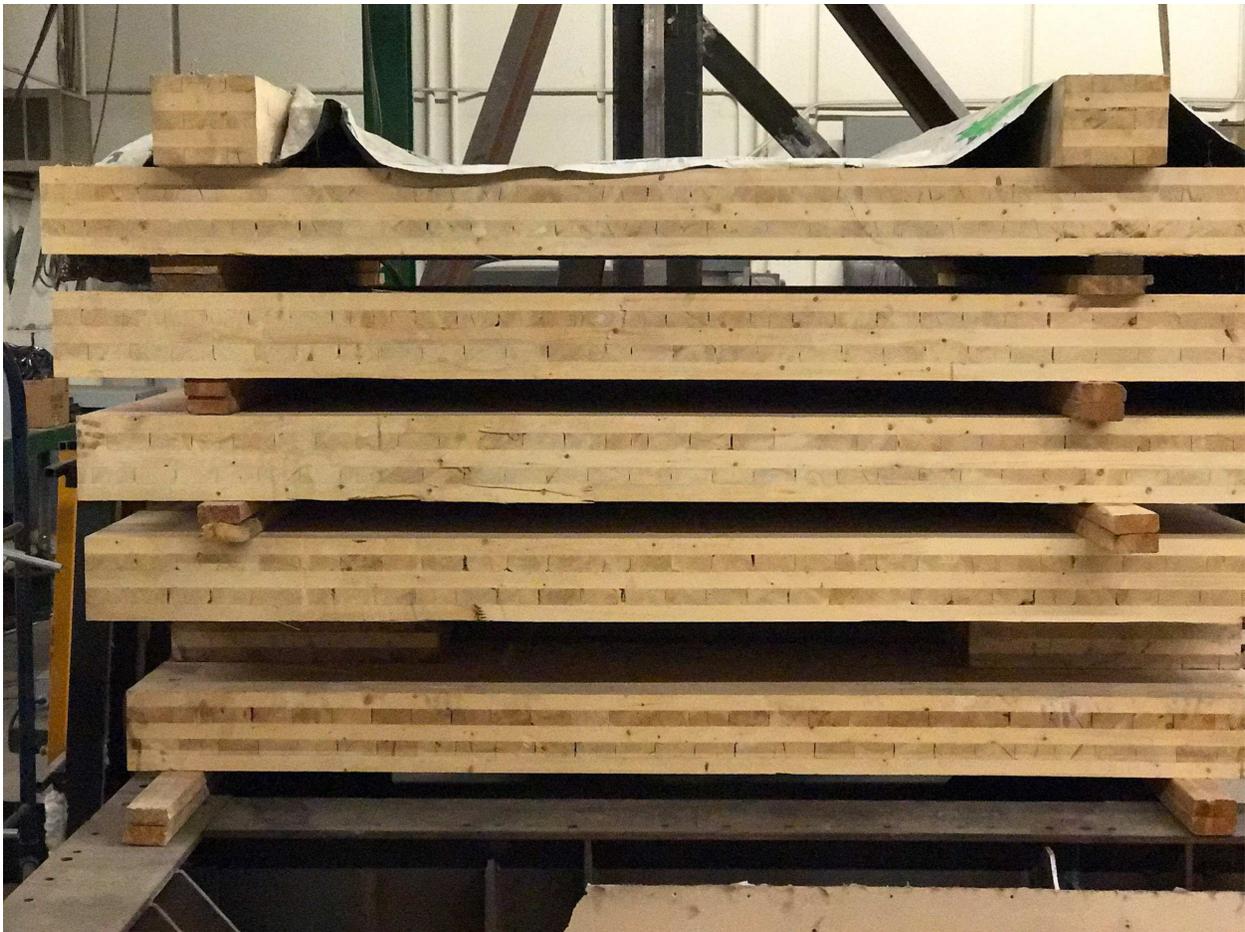
Figure 1.4 CLT Panels in the laboratory at Colorado State University

A CLT panel has at least 3 layers of lumber boards. The most commonly used CLT panels have 3, 5 or 7 layers. The lumber boards are typically 0.625 to 2 inches thick and from 2.4 to 9.5 inches wide. The size of a CLT panel depends on the manufacturer and is typically restricted by transportation constraints or the size of the press used to make the CLT. They are available in widths of 2ft., 4ft., 8ft. and 10ft. and can be 60ft. long in the U.S., but under 40 ft in length is more typical for transportation. The thickness can be up to 20 inches (FPInnovations, 2013). Figure 1.4 shows a side view of CLT panels.

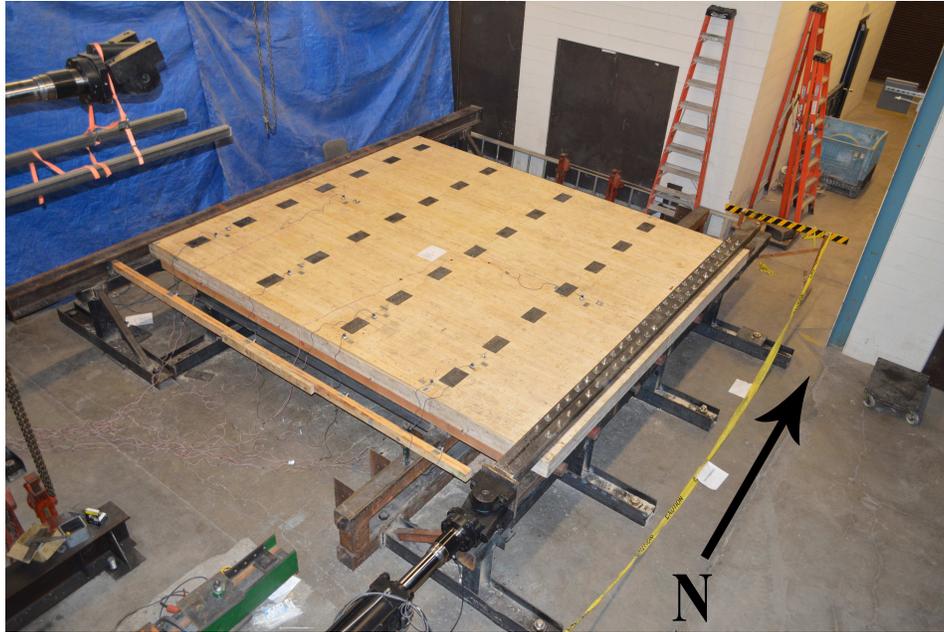
Figure 2.3 CLT Diaphragm Test Setup (View from a Top Angle)

Figure 2.3 shows a photo of the test setup from the top. The fixed end of the cantilever is on the west side of the test setup. A steel W beam is connected to CLT panels 5 and 10 to form the fixed end. Holes are drilled through the web of the steel I beam to make a fixed connection. The connection is made with lag screws that are drilled into the side grain of CLT panels. The SDS screw connection to the CLT panels from the top is shown in Figure 2.4. Figure 2.5 shows the rows of SDS screws drilled through the CLT panels. These SDS are 2.5” deep into the chord members underneath. This was done to ensure sufficient penetration for maximum strength.

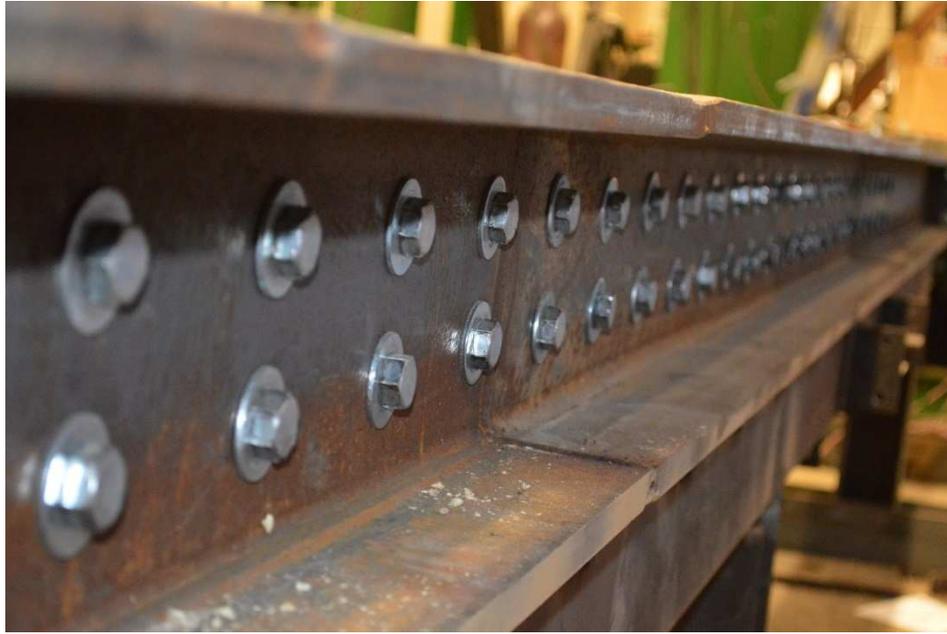
Figure 2.7 West End Steel I-Beam

Figure 2.7 shows the head of lag screws going through the web of the steel I-beam on the west side (fixed end of the cantilever) of the diaphragm. These lag screws are drilled into the side grain of the CLT panels. The steel beam and CLT panels are supported by tube steel that runs in the north-south direction under the steel I beam. A frame supports this tube steel. The steel frame starts on the west side. The first components are set underneath the tube steel on the fixed end. These act as legs to connect the fixed end to the concrete strong floor. The steel frame is fixed into the concrete strong floor with the use 2-inch threaded rod that have pre-drilled holes into the floor. The steel frame has kickbacks into the concrete floor. From this end, there are three long pieces of tube steel that span the length of diaphragm. These members are used to support the three chord members that support the diaphragm. The chord members are connected to the diaphragm with SDS screws.

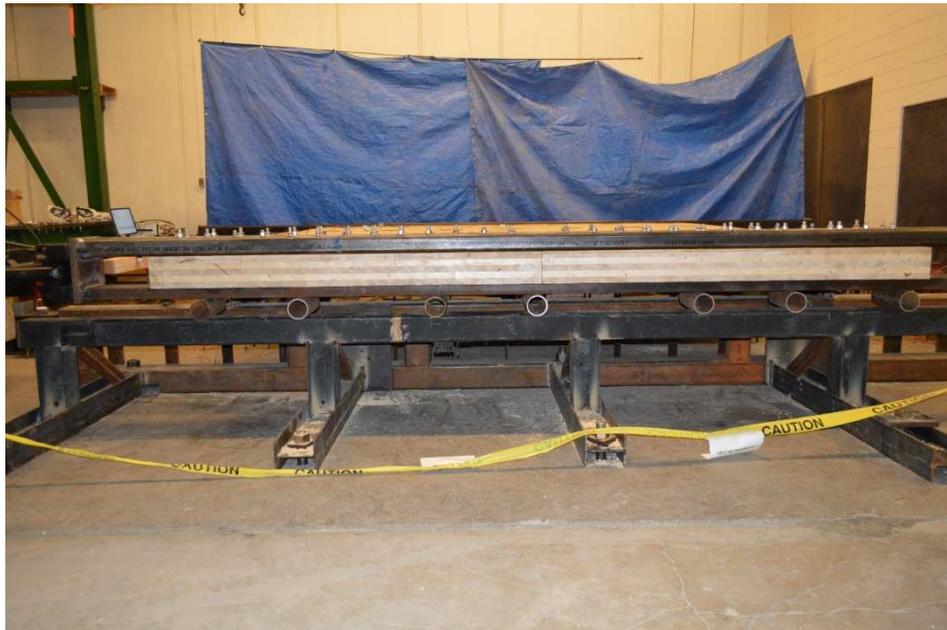
Figure 2.8 East End of the Test Setup

setup, these members connect to another steel frame. This steel frame has steel rollers on the top. These rollers are kept underneath the loader bar setup to reduce or eliminate any friction that would occur if it were sliding and allows the loader bar to move during testing. This is illustrated in Figure 2.8.

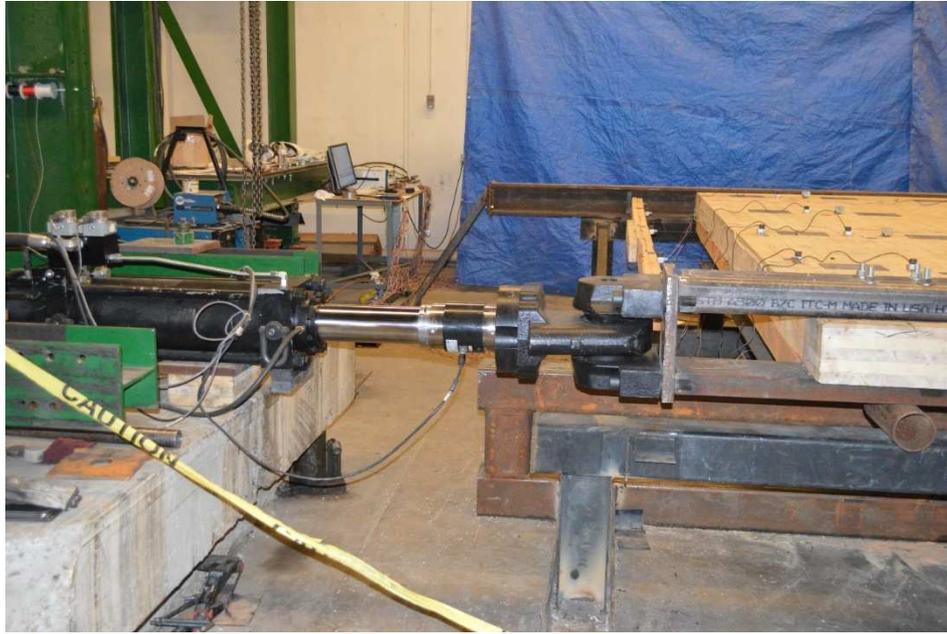
Figure 2.9 Southeast End of the Test Setup

At the south end of the loader bar the actuator is connected to the loader bar. The actuator sits on a block of concrete. The actuator is mounted on a steel plate that is connected to a steel beam that distributes the load into two steel beams that are placed into the strong concrete floor. At the end is another steel tube.

Figure 2.9 shows Actuator Connection to Loader bar. The Concrete Block underneath the Actuator is also visible. This provides support and acts as a kickback to control the resistance from loading when testing the diaphragm. All the other necessary drawings and photos have been included in the Appendix of this thesis.

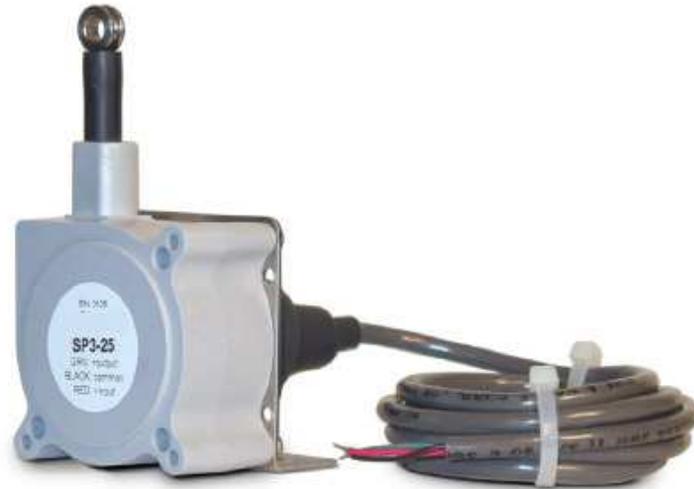
Figure 3.3 String Pot SP 3-25  
(<http://www.spectotechnology.com/wp-content/uploads/2014/05/StringPot-slide1.jpg>)

Thirteen string potentiometers were used to measure a variety of parameters. These devices are a type of transducers. They are used to measure displacement and linear velocity. String potentiometers are also called as string pots. A photo of a string pot is shown in Figure 3.3.

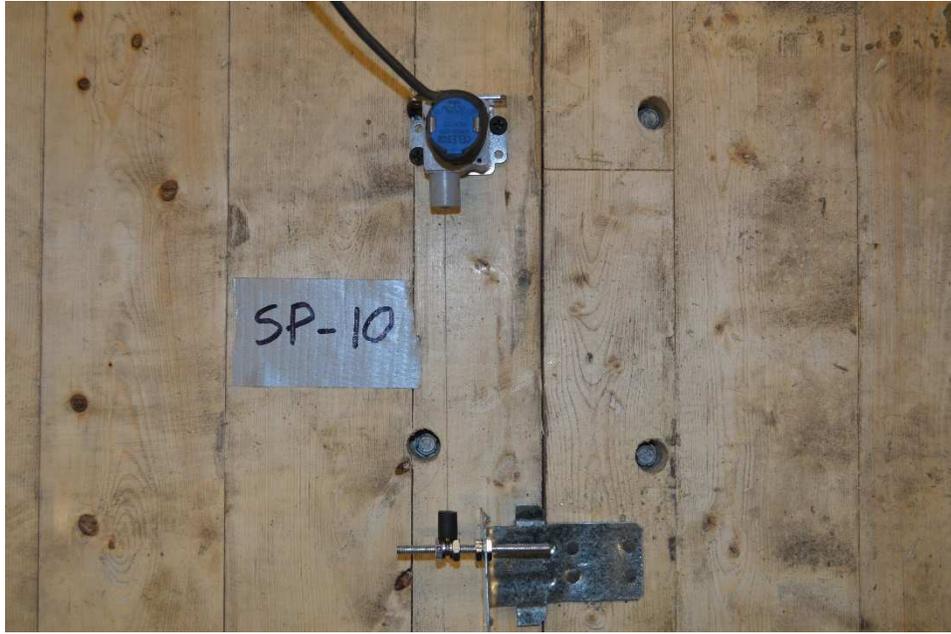
Photos of string pots 10 and 12 after installation are shown in Figures 3.7 and 3.8.

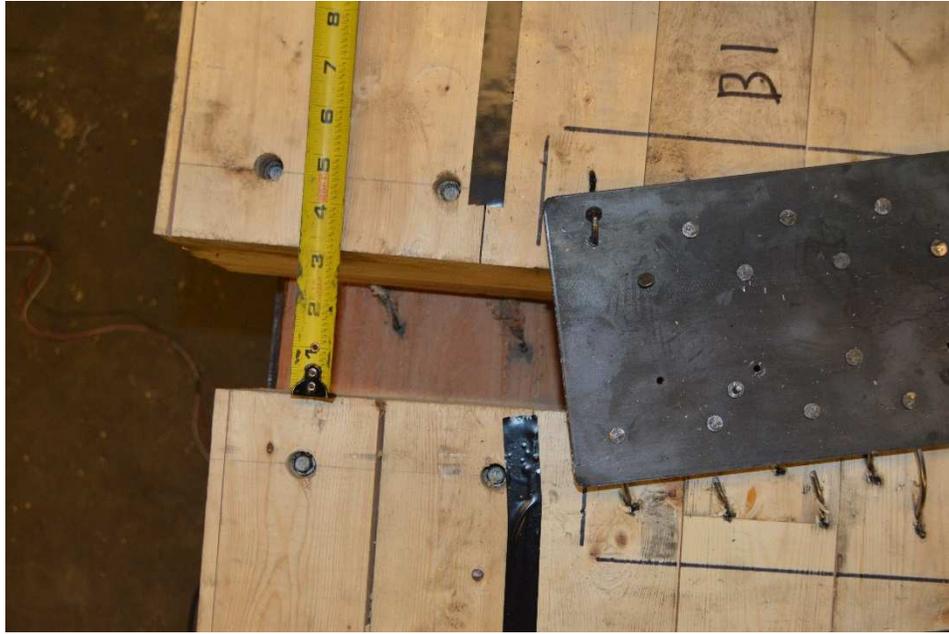
Due to cyclic loading, the separation between panels kept gradually increasing with the increase in actuator displacement as expected. This resulted in shear failure of SDS screws in the chord underneath the diaphragm and subsequent failure of the steel connectors. As one can see in Figures 4.3 and 4.4, the panels separated and the gap between the panels increased from less than 0.25 inches to more than 3 inches prior to stopping the protocol.

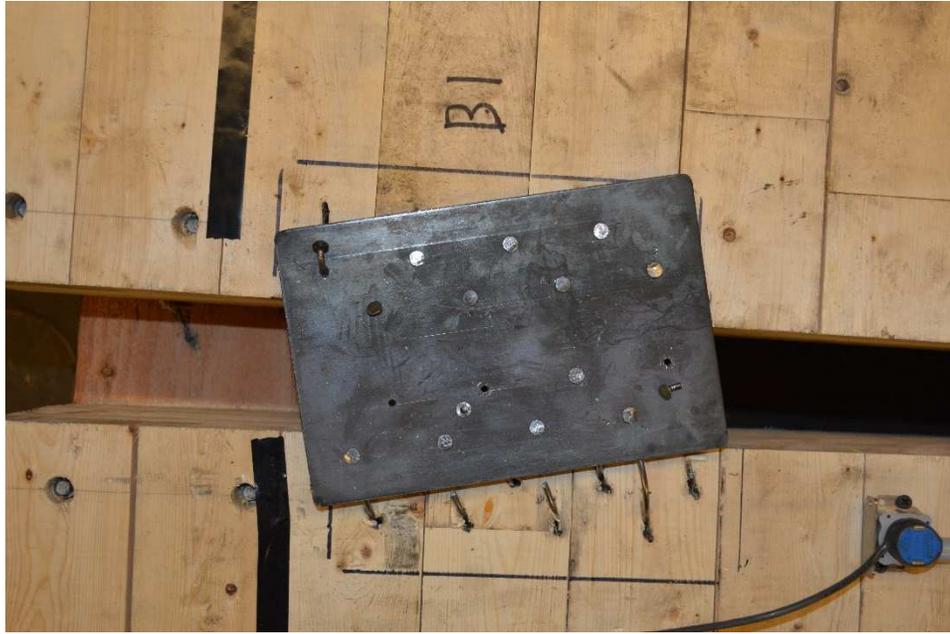
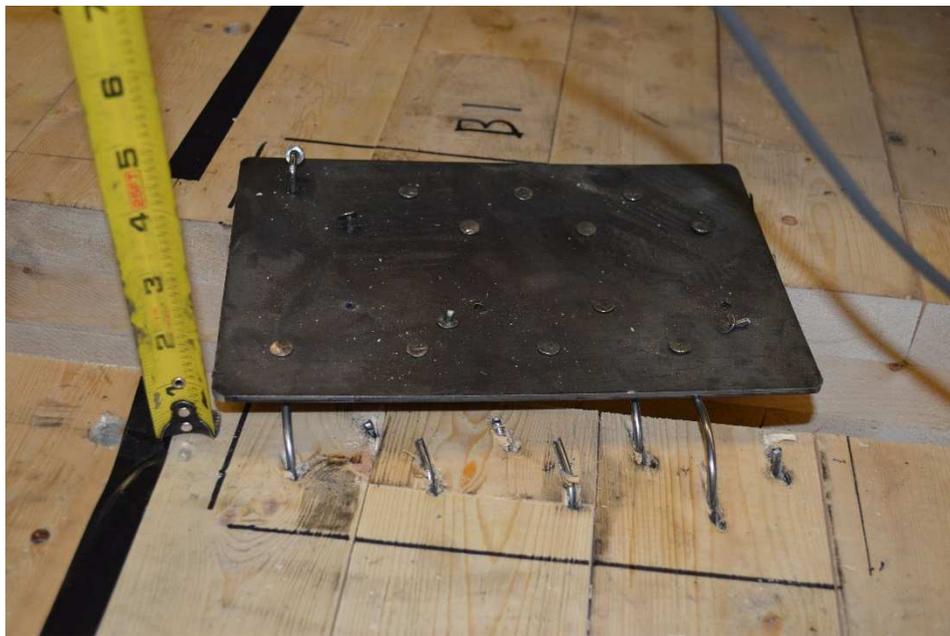
After the test, connector B1 had moved in the all three directions. In Figure 4.6, one can see the black outline of a marker around the connector B1 which was the original location of the B1 connector. It was twisted and turned due to cyclic loading. In Figure 4.7, we can see B1 did move out-of-plane because of the cyclic movement of the CLT panels. This type of failure occurred in all connectors on line B. More photos are included in Appendix.

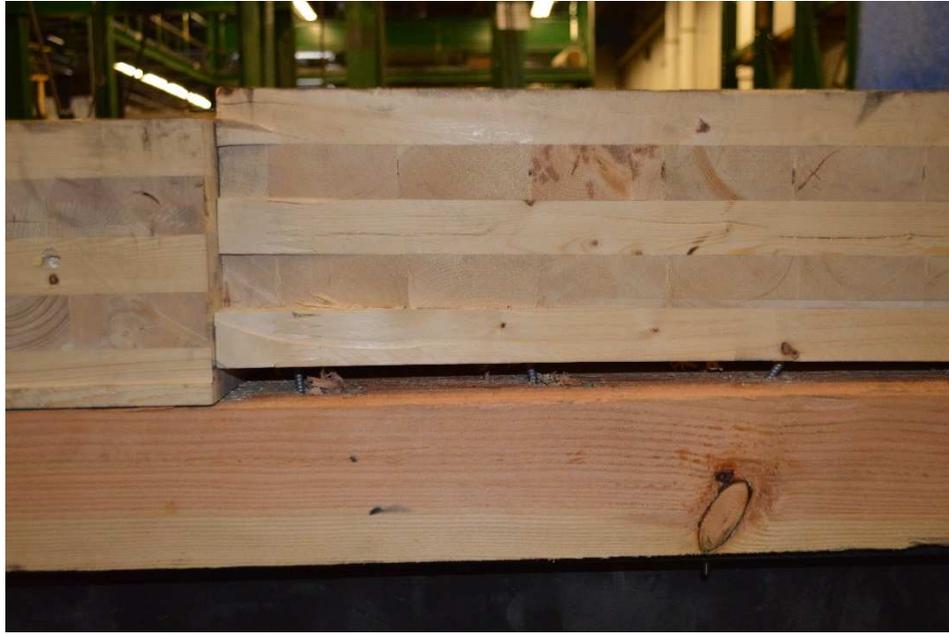
Figure 4.8 SDS screw shear failure

In Figure 4.8, one can see the side view of CLT panels 8 and 9 and the chord member underneath. Failure of the SDS screws in shear can also be seen in Figure 4.8. CLT panel 9 has some slight wood crushing. This is due to panels pushing at each other due to the cyclic movement of the panels. This can be seen in Figure 4.9.
