HYDRAULIC MODEL STUDY
LITTLE'S CREEK CHANNEL
LITTLETON, COLORADO

J. F. RUFF and S. R. ABT

COLORADO STATE UNIVERSITY
ENGINEERING RESEARCH CENTER
FORT COLLINS, COLORADO 80523

OCTOBER 1984

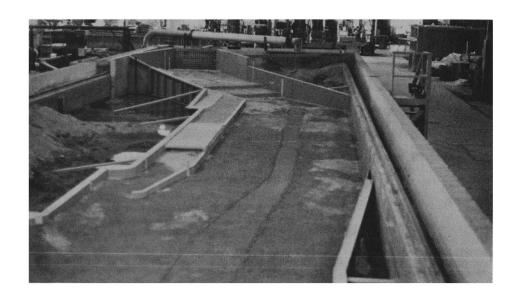
Figure 4 - Photograph Of The Model

The general location of Little's Creek and the limits of the model are shown in Figure 3. The dimensions of the model facilities and the arrangement are given in Figure 3 with a photograph of the completed model shown in Figure 4.

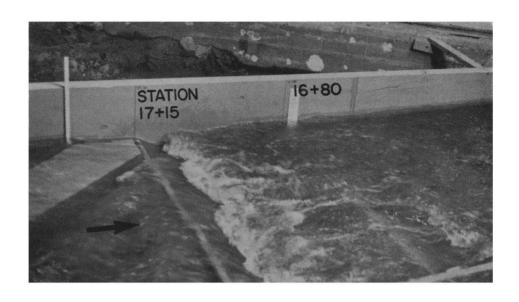
Figure 5 - Flow Conditions In Vicinity Of Drop Structure At A Discharge Of 2702 cfs.

The flow conditions in the vicinity of the drop structures during the scour tests at a discharge of 2702 cfs are shown in Figure 5. A small standing wave occurred upstream from Station 17+15. A hydraulic jump formed downstream from the drop at 17+15. Initially, little energy dissipation was evident downstream from the drop at Station 16+80. As the run proceeded, the bed below both drop structures eroded. The eroded holes provided pools in which hydraulic jumps formed.
