HYDRAULIC MODEL STUDY  
OF THE  
KREMASTA DAM SPILLWAY

KREMASTA HYDROELECTRIC PROJECT  
ACHELOOS RIVER DEVELOPMENT  
GREECE

ADDENDUM I  
FLIP BUCKET RELOCATION

S. S. Karaki  
Hydraulics Laboratory  
Colorado State University

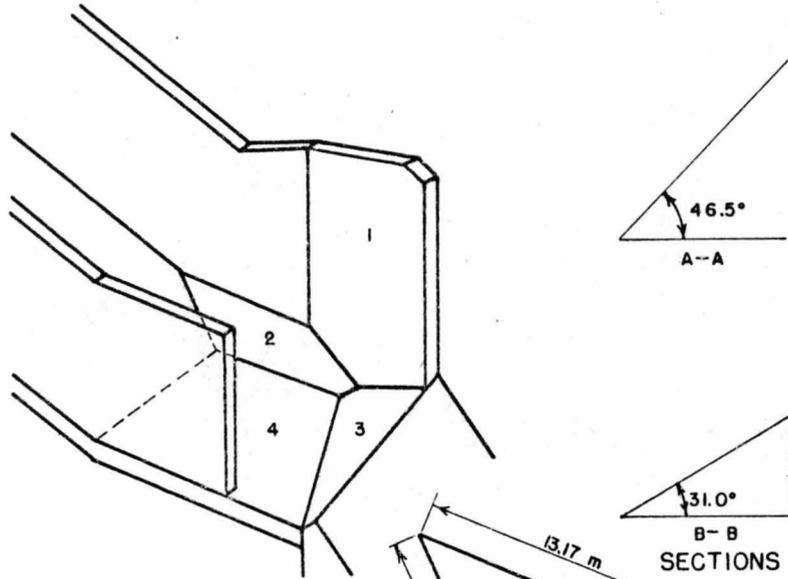
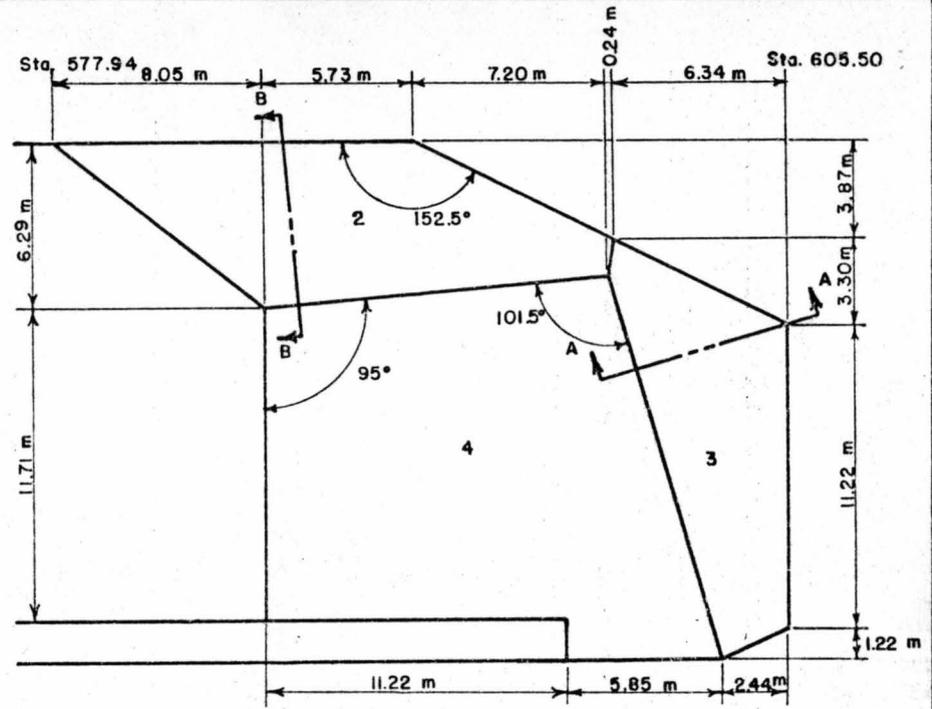
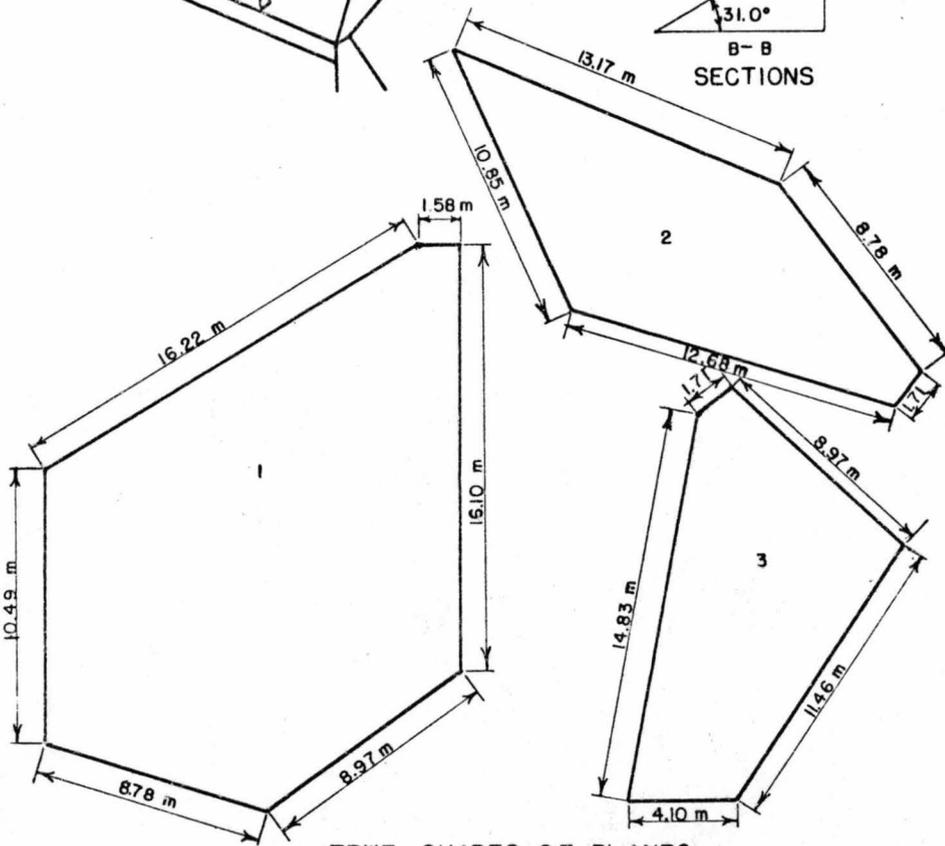
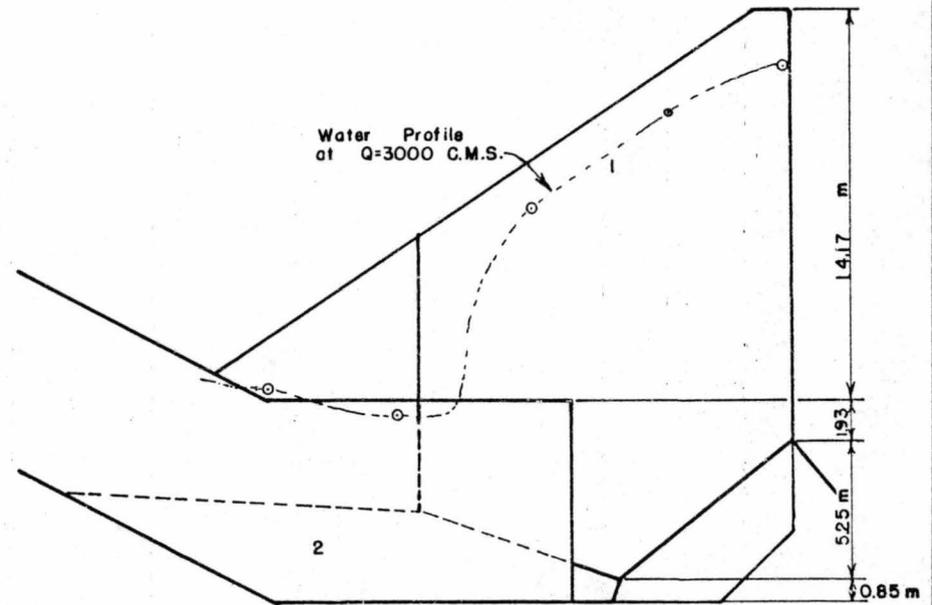
Fig. 64 RECOMMENDED FLIP BUCKET GEOMETRY

PLAN OF FLIP BUCKET

TRUE SHAPES OF PLANES

PROFILE OF FLIP BUCKET

Due to a slightly lower velocity of flow through the flip bucket in the revised location and the resulting greater flow depth, the left wall height of the recommended flip bucket has been increased. A higher flow line along the left was also caused by interception of the standing wave at a different point from the original flip bucket location. The pertinent dimensions of the recommended flip bucket are shown in Figure 64.

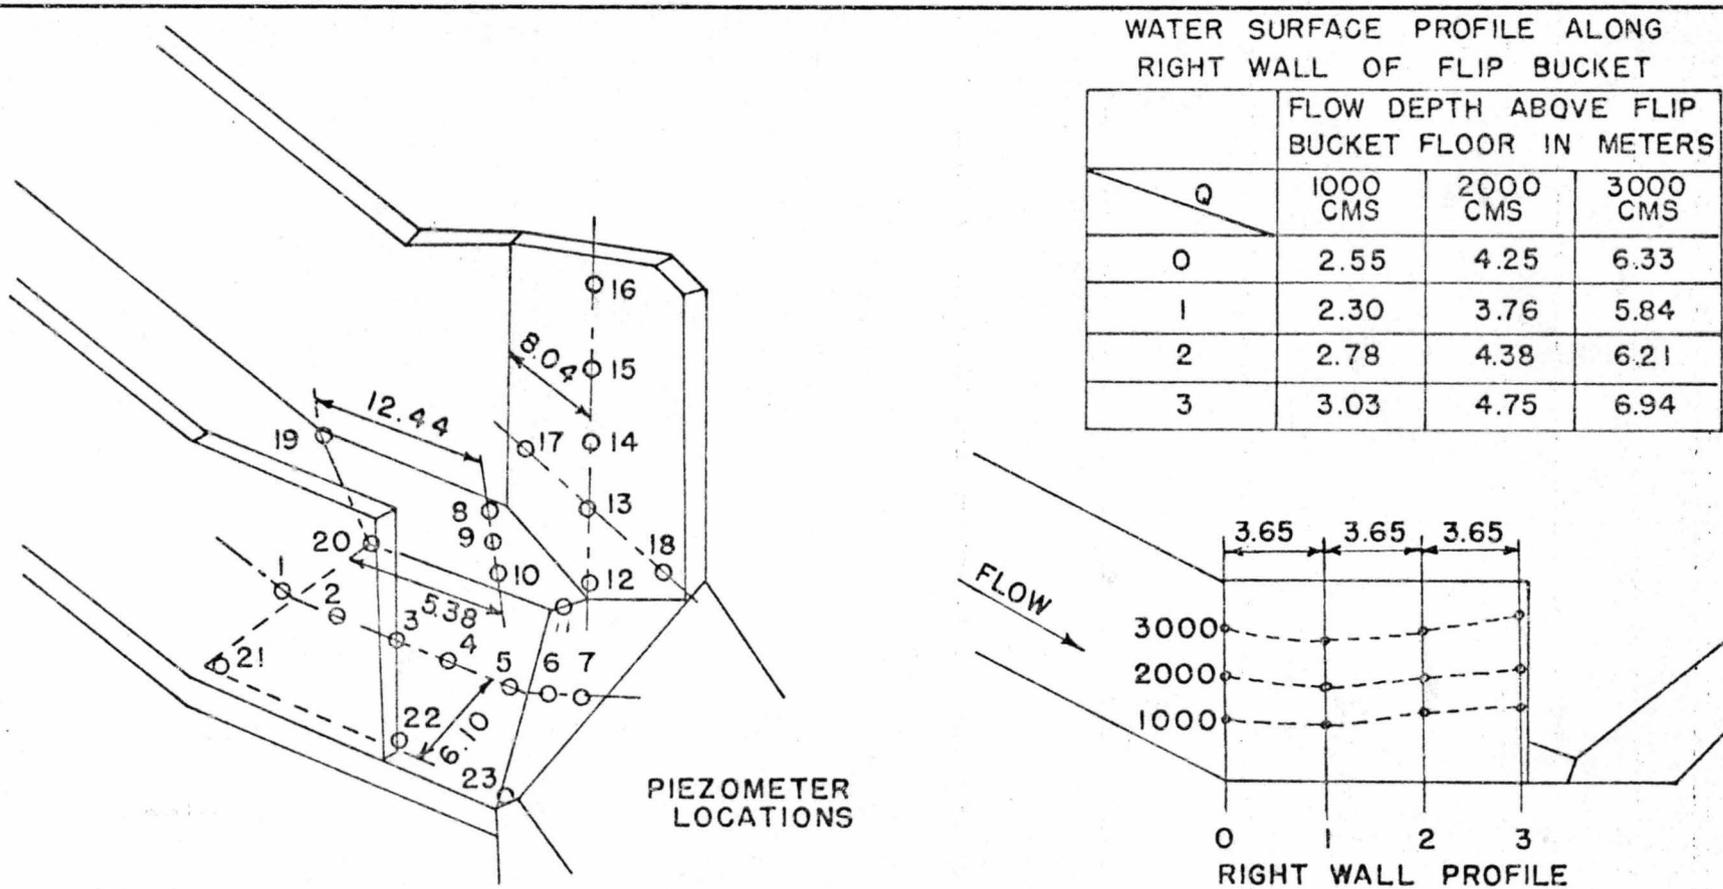
Figure 65 Water Surface Profiles and Pressure Heads in Flip Bucket

PRESSURE HEADS IN FLIP BUCKET IN METERS OF WATER PROTOTYPE

Dynamic pressure heads were measured at selected points in the model flip bucket at a prototype discharge of 3000 cms. The pressure point locations and measured pressure heads are shown in Figure 65. No negative pressures were recorded. Figure 65 also shows the water surface profile along the right wall of the flip bucket for discharges of 1000, 2000, and 3000 cms.

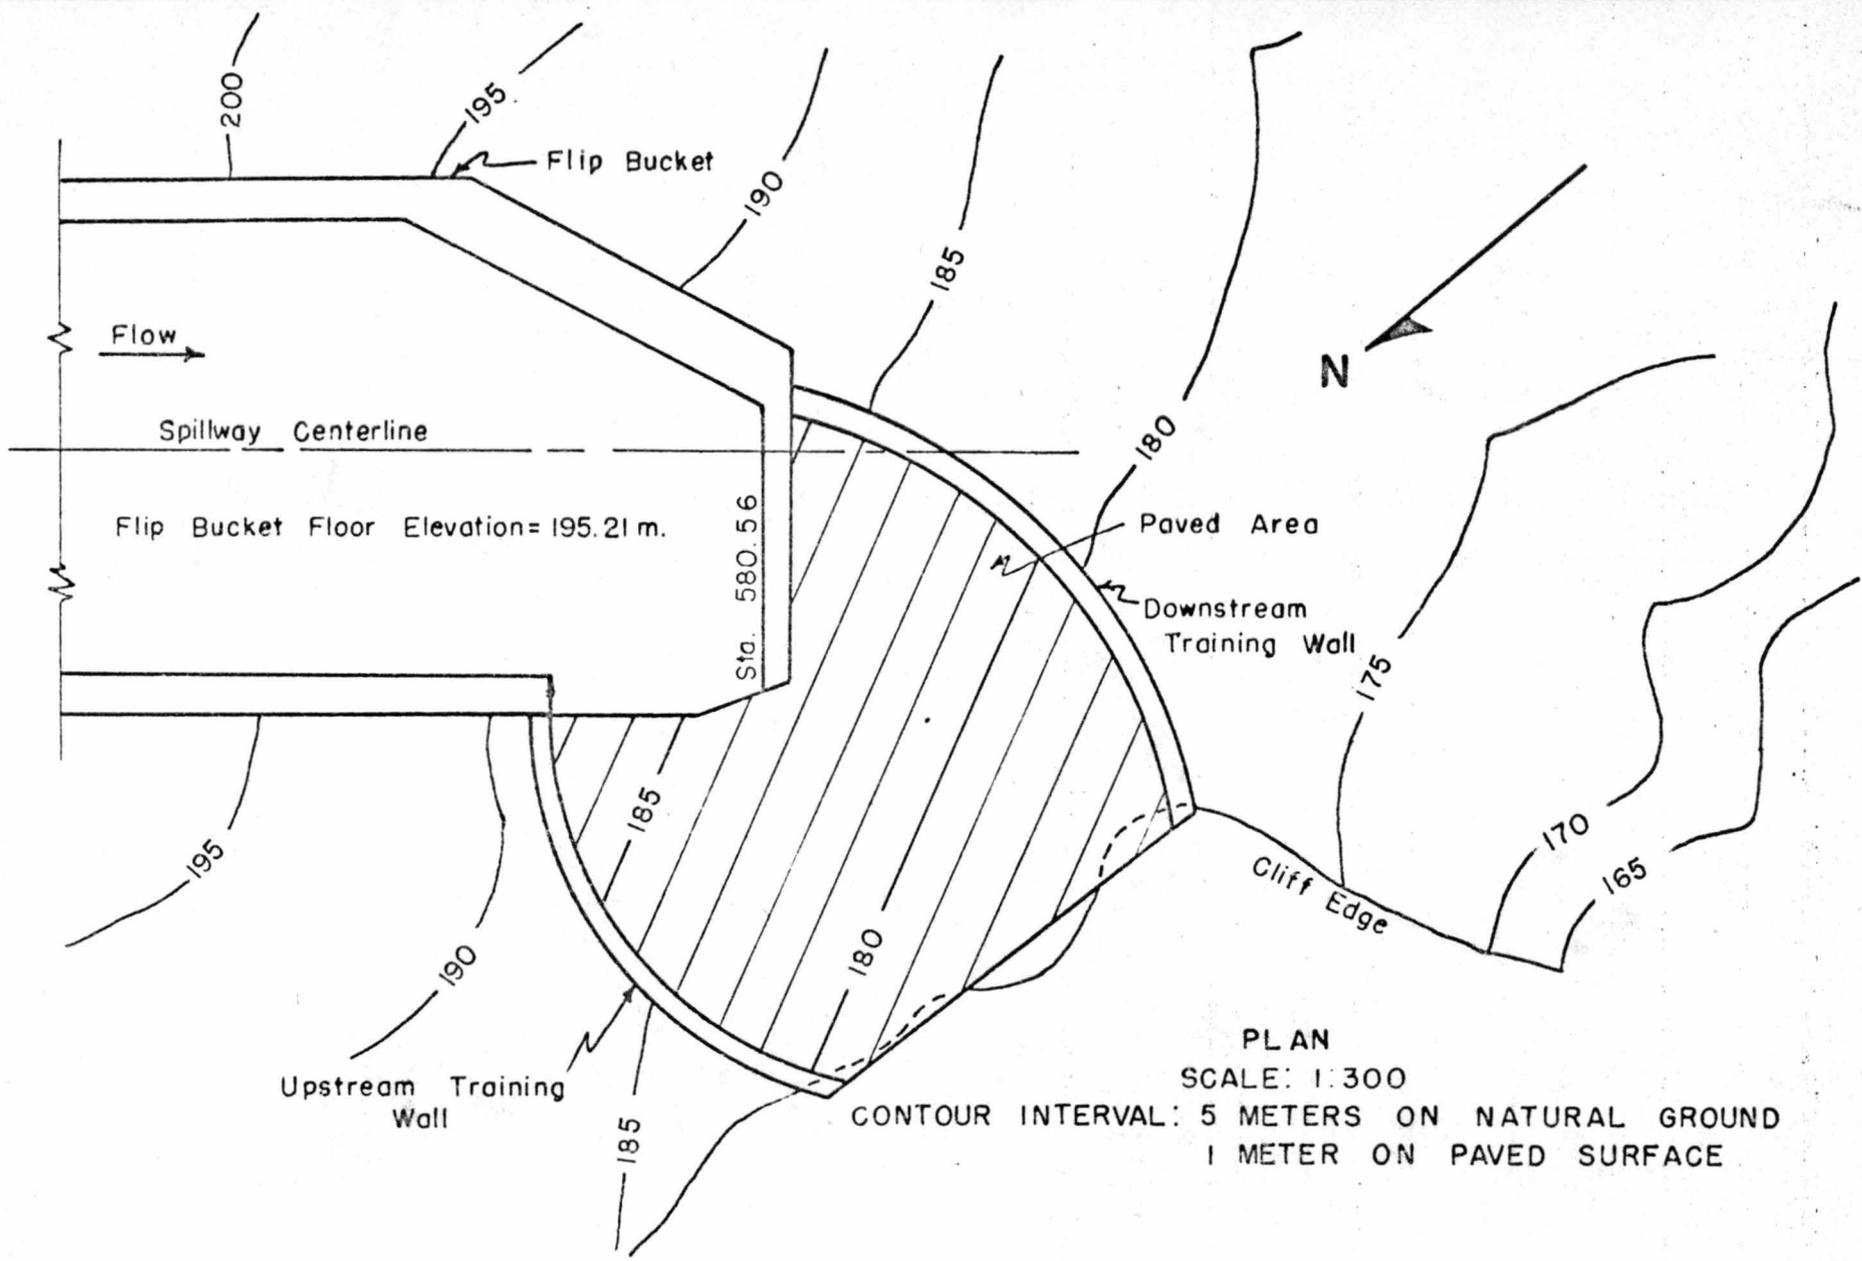
FIGURE 66 SLOPE PROTECTION, PRELIMINARY DESIGN

The first method investigated, as proposed by Engineering Consultants Inc., consisted of a paved area bounded by the flip bucket, two curved training walls and the cliff edge as shown in Figures 66 and 67. The flow at the right was contained by a wall tapering in height from 2.0 meters at the flip bucket to 4.5 meters at the edge of the cliff. A freeboard of

1.0 meter is afforded by this wall height. A fillet at the base of the wall was provided. Although this fillet is not required for hydraulic reasons it might be used to structurally stabilize the wall. The left wall was 4.0 meters in height which contained discharges up to 50 cms, but was not adequate for higher discharges. Discharges above 50 cms, but less than 200 cms impacted on the hillside downstream of the wall. Figures 68(a) through 68(c) illustrate the flow conditions for discharges of 50, 100, and 150 cms. The jet for discharges above approximately 200 cms cleared the cliff edge as shown by Figure 69.

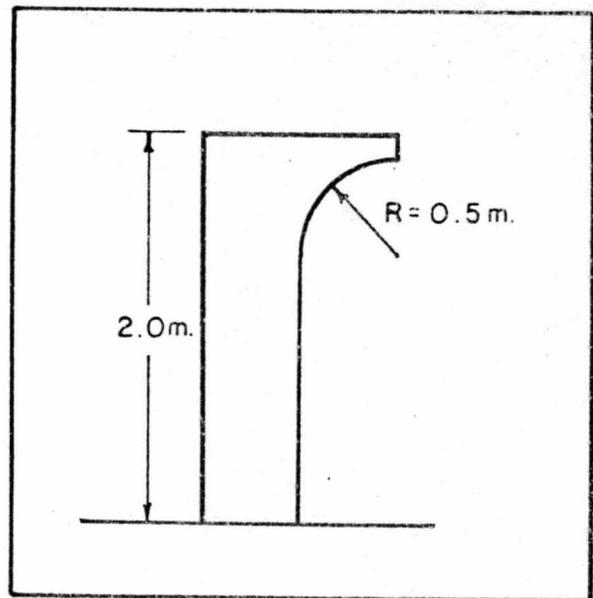
Figure 72 Vertical section of left wall at the downstream end of paving.

Downstream walls of various heights and alignments were tested to determine an economical and effective solution to the problem. The recommended slope protection consists of a large paved area bounded by the upstream curved wall described above, the flip bucket, the cliff edge, and a straight vertical wall 2.0 meters in height extending along the left edge of the paving from the flip bucket to the cliff edge as shown in Figures 70 and 71. In order to prevent overtopping near the downstream end of the left wall without increasing the wall height, it is recommended that a curved deflector be constructed 16 meters long, along the downstream length of the wall as shown in Figure 72.

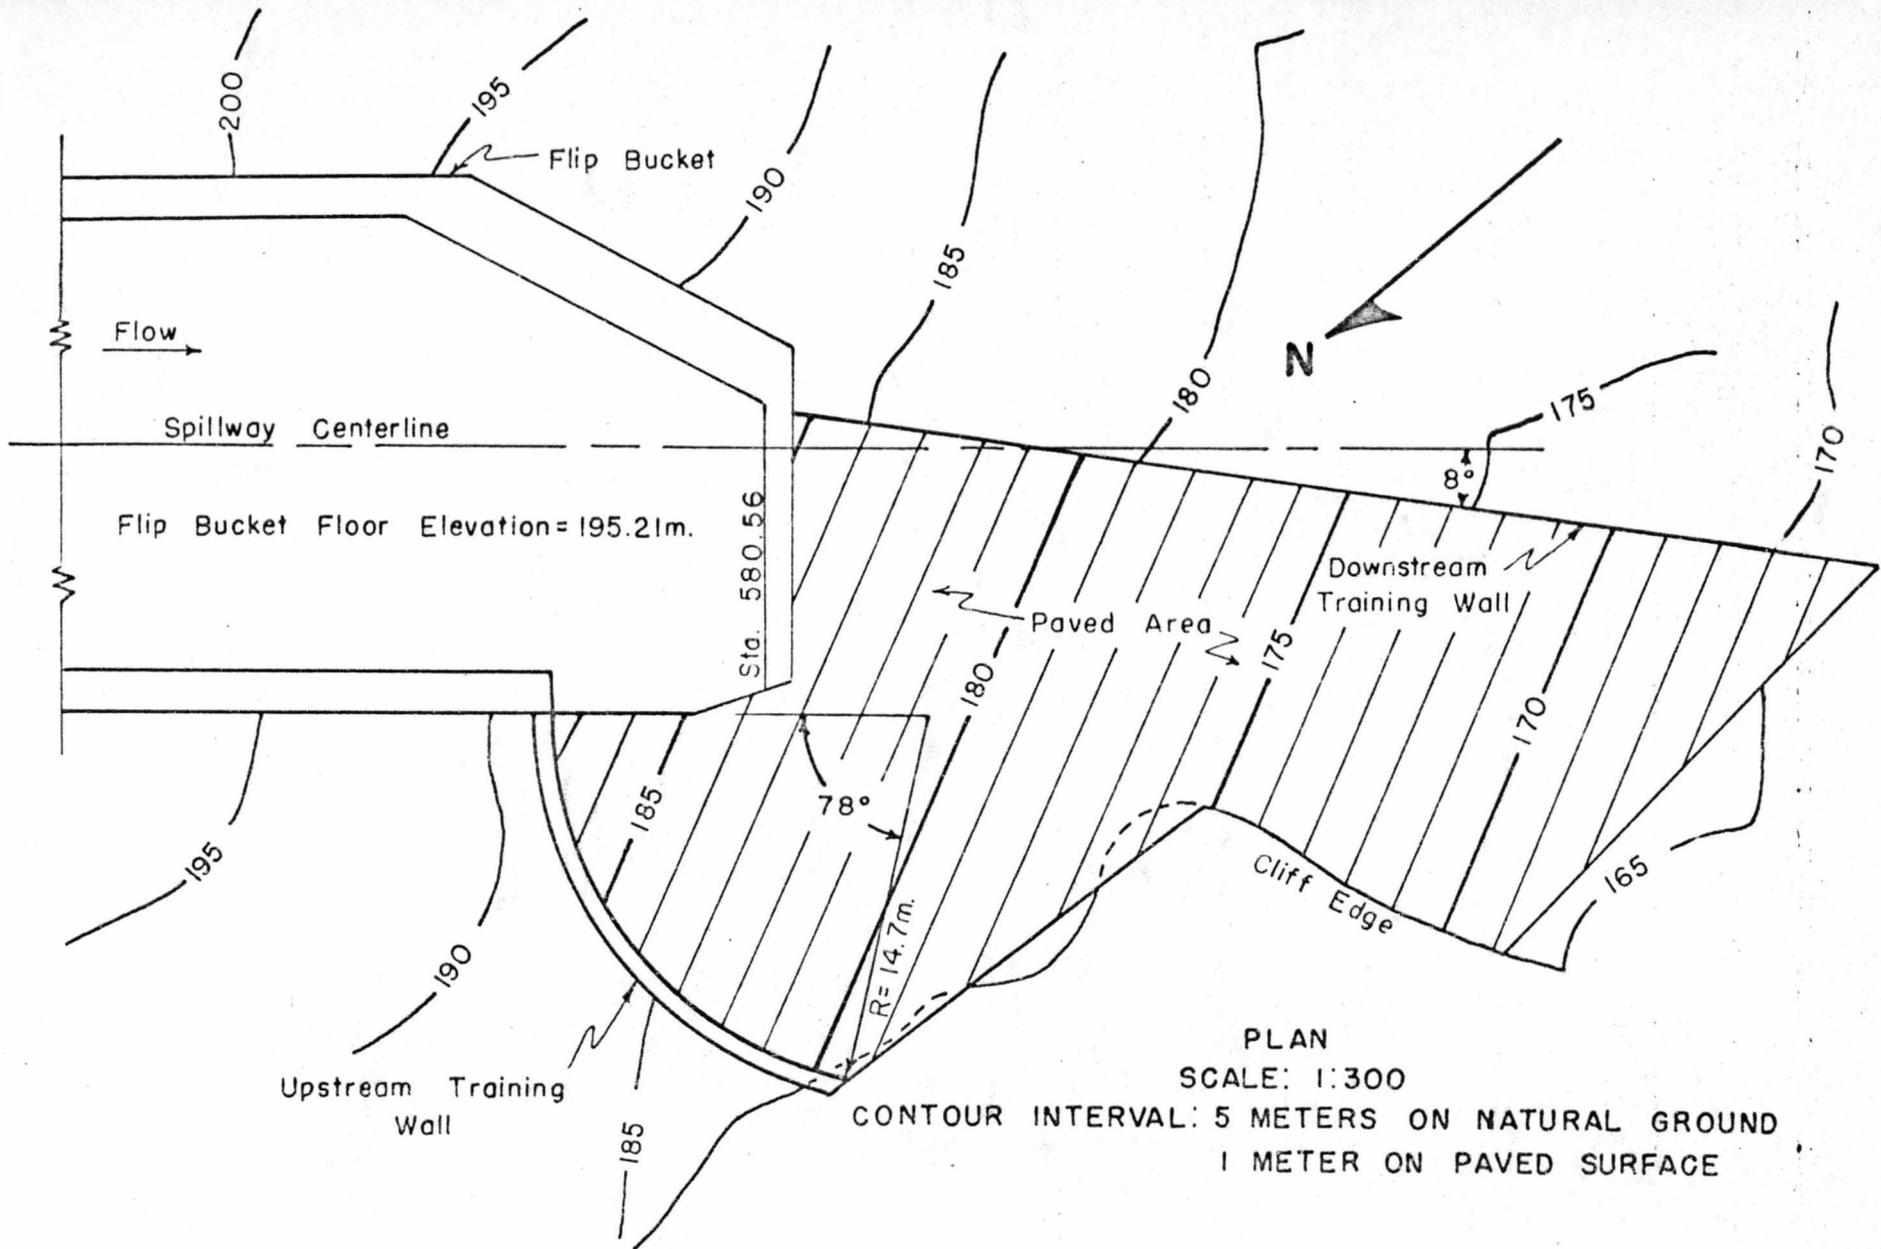
FIGURE 70 SLOPE PROTECTION, RECOMMENDED DESIGN

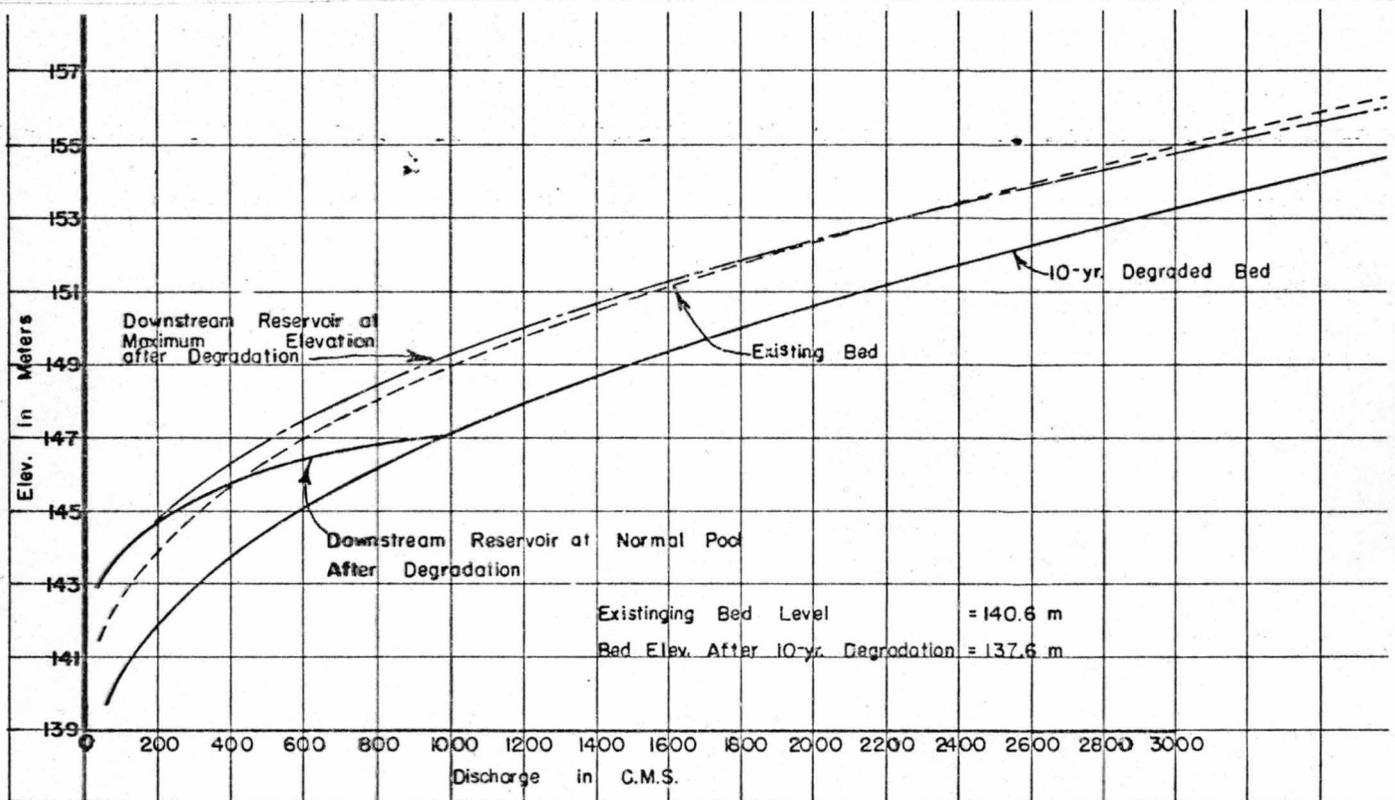
Figure 75 STAGE DISCHARGE RATING CURVES AT MODEL GAGING STATION

The stage-discharge curves at the location of the model gaging station are reproduced as Figure 75 which coincides with Figure 53 of the parent report.

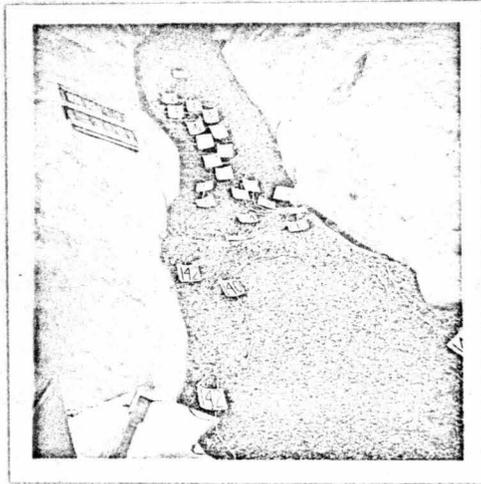
Figure 78(a) Scour pattern with 3/8-in. gravel  
 Spillway  $Q = 3000$  cms  
 Power plant  $Q = 400$  cms  
 Model time = 40 min.  
 Maximum scour El. = 124 m

The development of scour in the river bed with the 3/8-inch gravel and spillway discharge of 1000 cms is shown in Figure 76(a). The tailwater levels at the power plant are shown in Figure 76(b) with progressive stages of scour beginning with the existing river bed level at elevation 140.6 m. The white lines in the photograph are contour lines. The minimum elevation in the scour hole was 128.0 m. Test results for discharges of 2000 and 3000 cms are shown in Figures 77 and 78 respectively. The power plant wall was not overtopped in any of the tests.

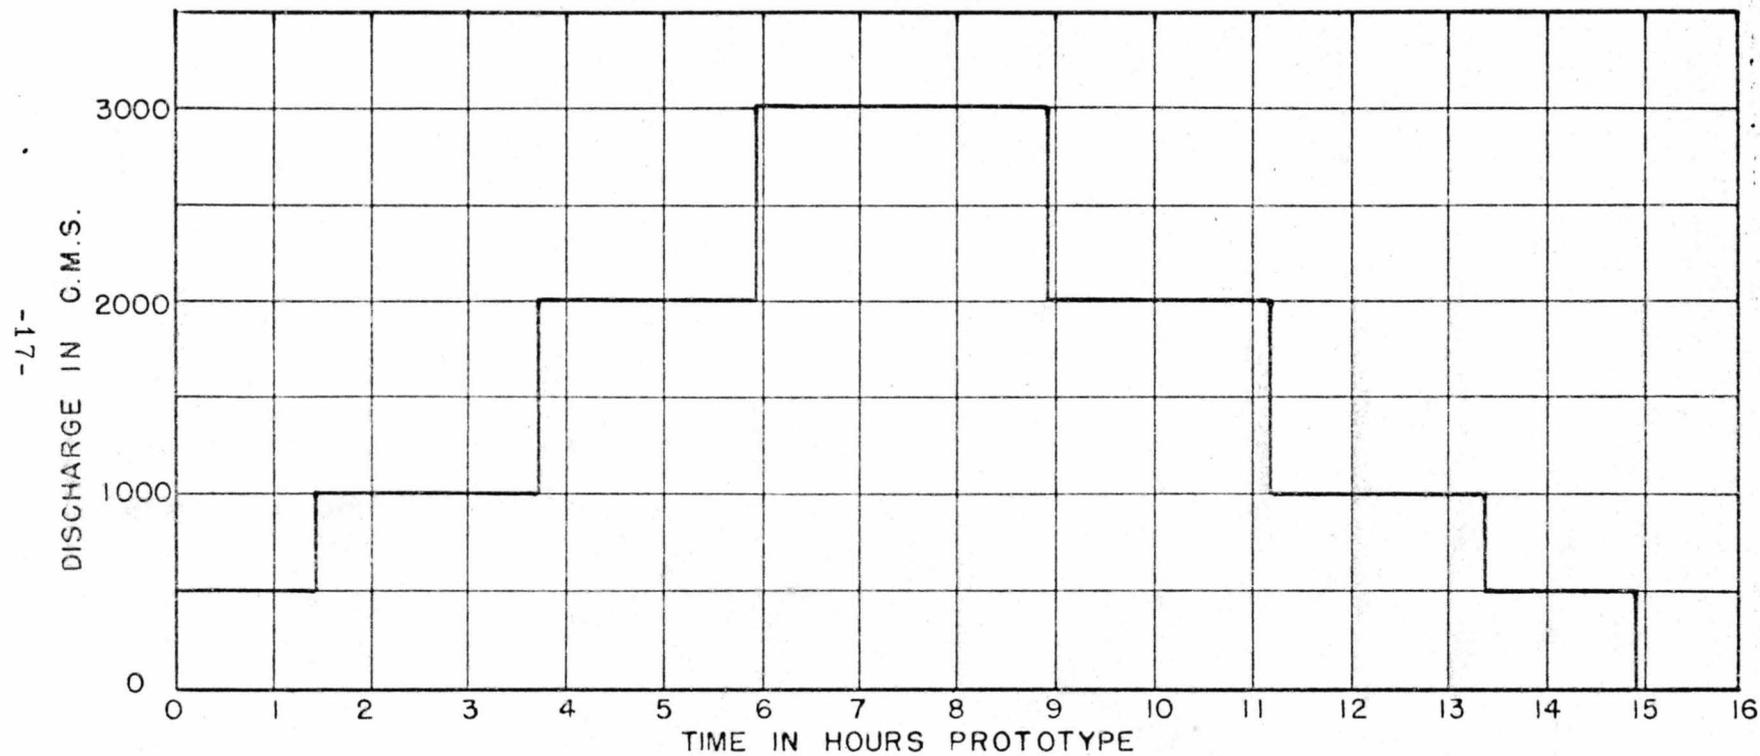
Figure 79 STEP HYDROGRAPH

Scour development after a flow cycle, the hydrograph of which is shown in Figure 79, is shown in Figure 80(a). The scour area was more extensive and a greater amount of river bed material was transported downstream. Variation of tailwater levels with discharge are shown in Figure 80(b). The maximum tailwater level was 153.1 m providing 2.9 meters of freeboard to the top of the wall. On the recession cycle of the hydrograph the power plant was shut down and tailwater levels were measured with only the spillway flows. The result is shown in Figure 80(c).

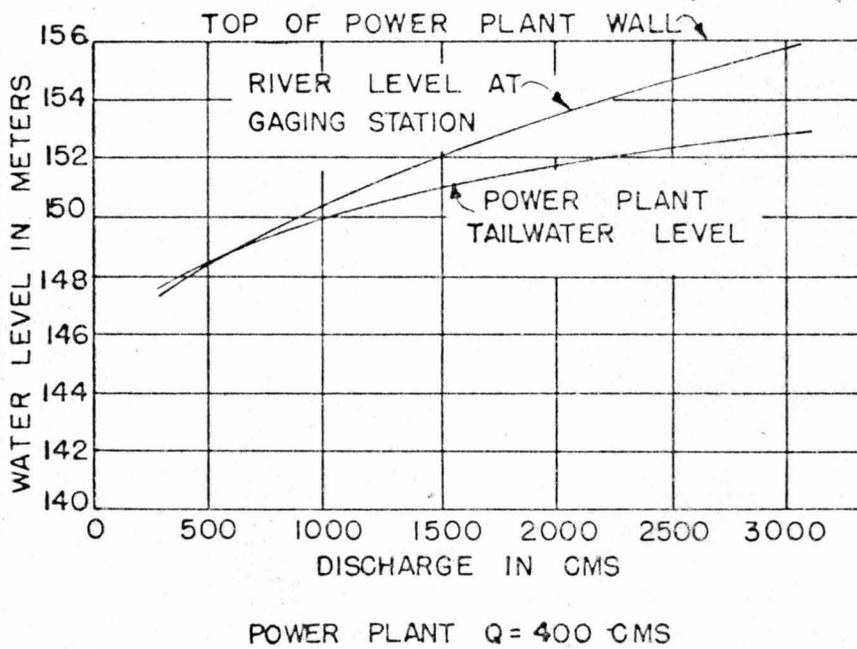
Figure 80(b) Power plant tailwater level.

Because of the gravel bar formed downstream of the scour area, the tailwater levels at discharges less than 2000 cms were higher than at corresponding discharges during the ascending cycle of the hydrograph. There was sufficient freeboard to the top of the power plant wall at all discharges.

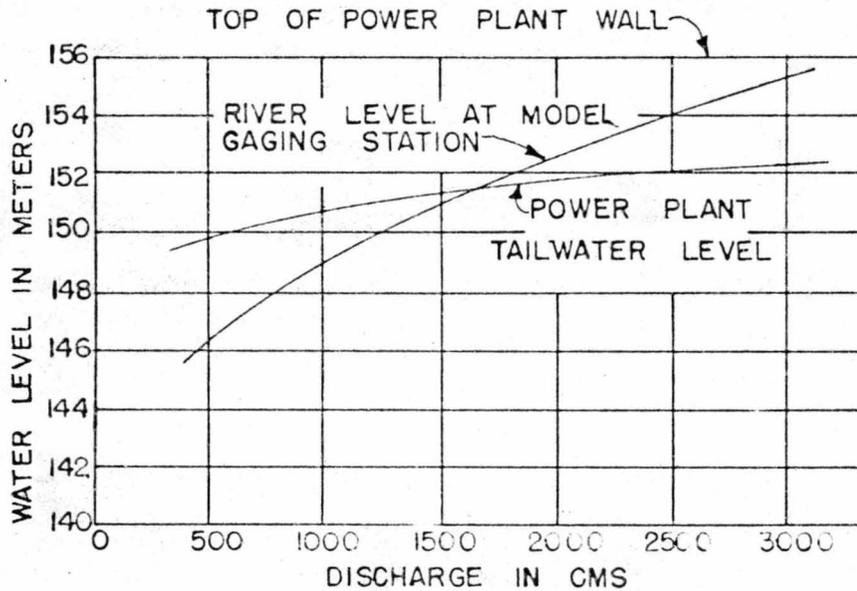
Figure 80(c) Power plant tailwater level. No power plant discharge

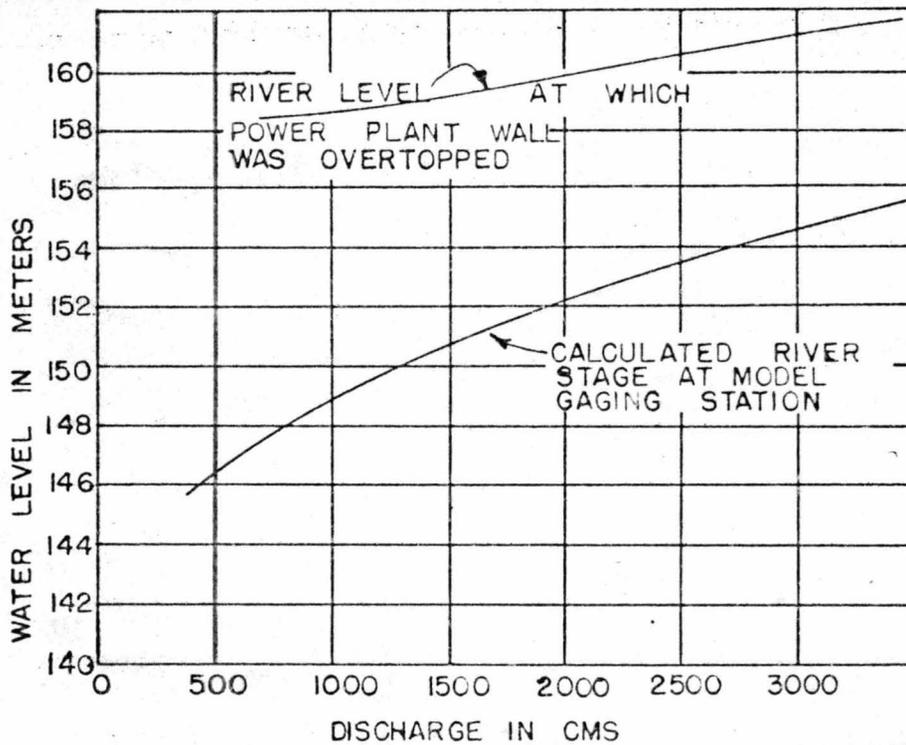
Figure 81 River stage studies

To determine at what river stage the power plant wall would be overtopped, tests were run at several discharges with imposed high-river levels to cause overtopping. The tests were made with maximum discharges through four turbine units. Results are shown in Figure 81. There was at least 5.5 meters of allowance in depth between the calculated stage and that which would cause overtopping.

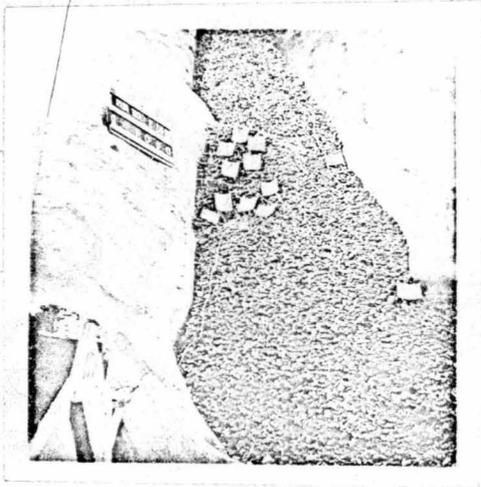
Figure 82(a) Scour patterns with  
3/4-inch gravel  
 $Q = 1000$  cms

The results of tests with 3/4-inch gravel in the model river bed are shown in Figures 82(a) through (c) for discharges of 1000, 2000, and 3000 cms. The power plant tailwater levels were the same as tests with the 3/8-inch gravel bed.

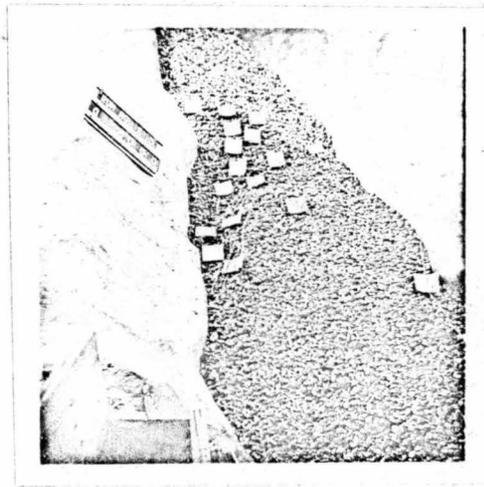
Figure 82(b) Scour patterns with  
3/4-inch gravel  
 $Q = 2000$  cms

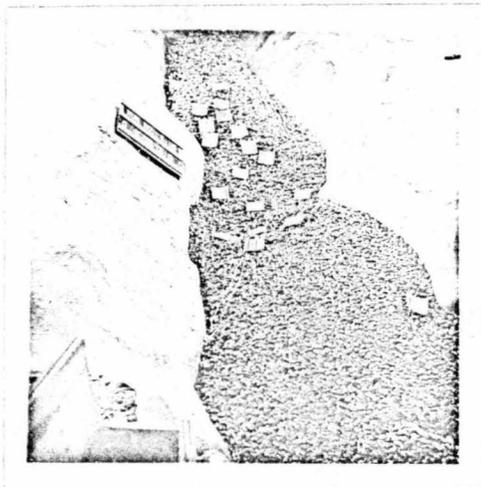
Figure 82(c) Scour patterns with  
3/4-inch gravel  
 $Q = 3000$  cms

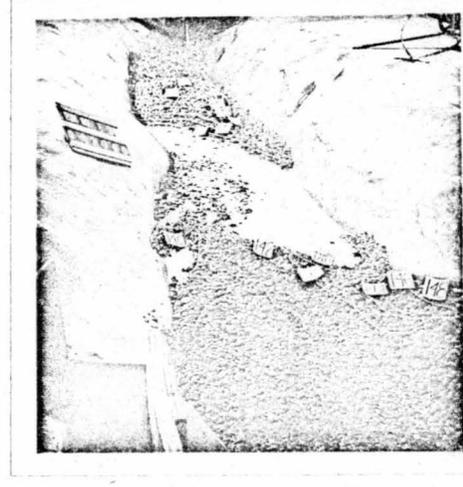
Figure 83(c) Scour patterns with bed rock at elevation 139.0 m  
 $Q = 3000$  cms

Tests results with river bed rocks located at elevation 139.0 m are shown in Figures 83(a) through (c) for discharges comparable to Figure 82. Measured tailwater levels at the power plant are shown in Figure 84. The tailwater at the power plant was lower for corresponding discharges during tests with the bed rock at elevation 139.0 m than during tests with the bed rock at elevation 115.0 m. This was because of the draw-down effect of the flip bucket jet. No apparent tailwater problem will arise if bed rock is near the present river bottom.

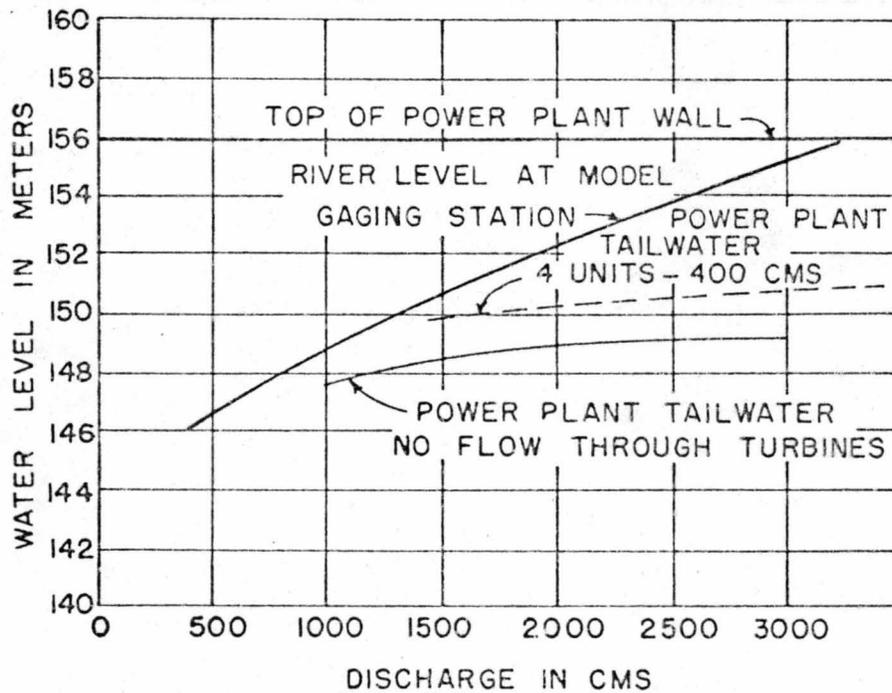
FIGURE 84 POWER PLANT TAILWATER LEVELS  
 BED ROCK AT ELEV. 139.0
