Middle Rio Grande Conservation Action Plan

Framework and Status Assessment

Final Report

April 2015

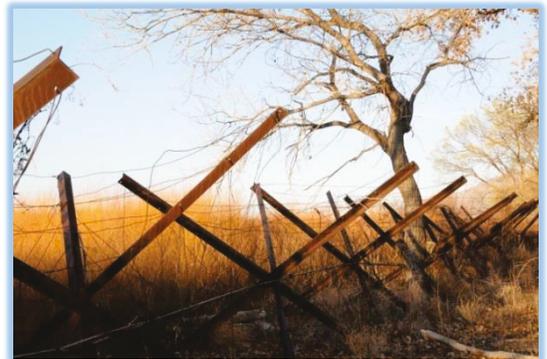
Kellner jetty jacks were installed along the banks and through the floodplain to stabilize and prevent lateral movement of the river channel.

Over the course of the last 90 years, a variety of methods have been used to channelize the river including levees, groins, Kellner jetty jacks, and dredging. The end result has been a significantly narrower and deeper active channel that flows between raised terraces of deposited sediment within the levee system. This is effective for water delivery and flood control, but is detrimental to the wetland and riparian flora and the native aquatic fauna. As the active channel has become progressively more isolated from the adjacent terraces there has been a decrease in the extent and frequency of overbank flooding onto the terraces, coupled with a retreating groundwater table in the terraces. The lack of overbank flooding means that many of the native riparian woody species can no longer reproduce outside of the active channel. The lack of geomorphological diversity in the active channel and overbank flooding outside the channel also impacts the reproductive success of endangered native fish species. The retreating groundwater has

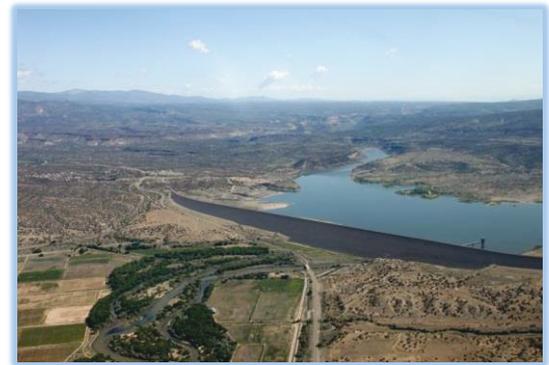
Cochiti Dam lies at the northern boundary of the MRG reach and is the primary means of water regulation.

Threats due to dam operations refer only to the larger dams capable of retaining significant amounts of sediment and water in pools. These include Galisteo, and El Vado and Abiquiu in the Chama basin, but Cochiti is the first major dam on Rio Grande itself and the most significant in its effects on the Middle Rio Grande. The smaller irrigation diversion dams that do not create large retention pools (Angostura, Isleta, and San Acacia) are discussed under Diversions. The large dams were constructed from the 1930s to the 1970s and were built for flood abatement and/or water storage.

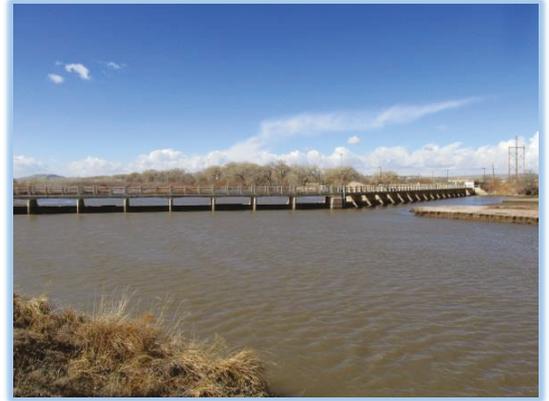
The Isleta diversion dam provides irrigation water for the MRGCD Belen Division.

The dams and other diversion infrastructure can be a direct threat to fish by impeding movement up or down channel, especially if fish become trapped in areas that may dry completely and create population sinks. Impediment of up- and down-channel movement can also create genetic isolation between fish populations.

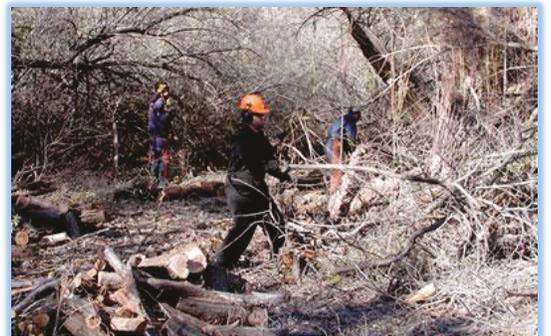
Understory treatments to reduce fire hazards can impact wildlife habitat and vegetation diversity depending on how they are done.

Fire suppression and treatment activities can be a threat or a boon to the ecosystem depending on how they are conceived and carried out. Land managers have addressed
